# FINAL ENVIRONMENTAL ASSESSMENT VOLUME II

## Replacement Passenger Terminal and Enabling Projects

Des Moines International Airport Des Moines, Iowa

Traffic and Safety Report

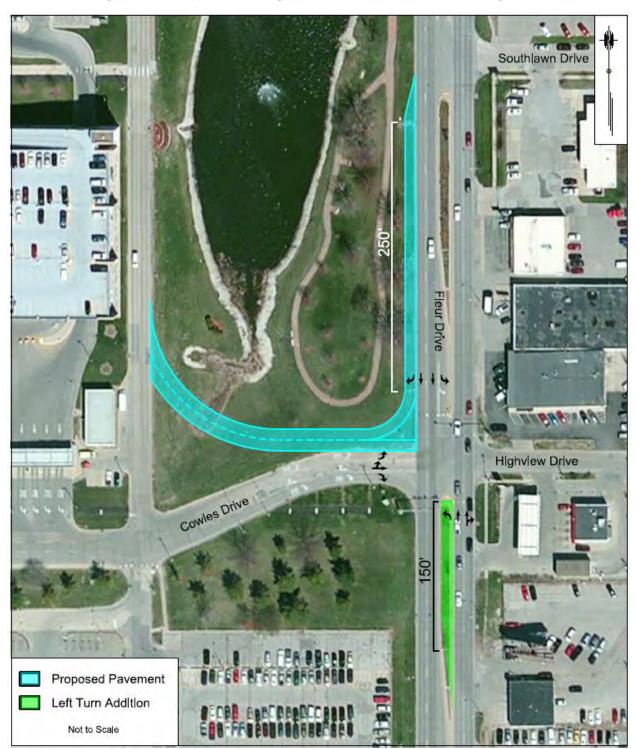
Figure I-1. Proposed Configuration of Fleur and Cowles/Highview

**Figure I-1** on the next page shows the proposed roadway configuration for Fleur and Cowles/Highview. **Appendix C** shows the full set of preliminary design plans.

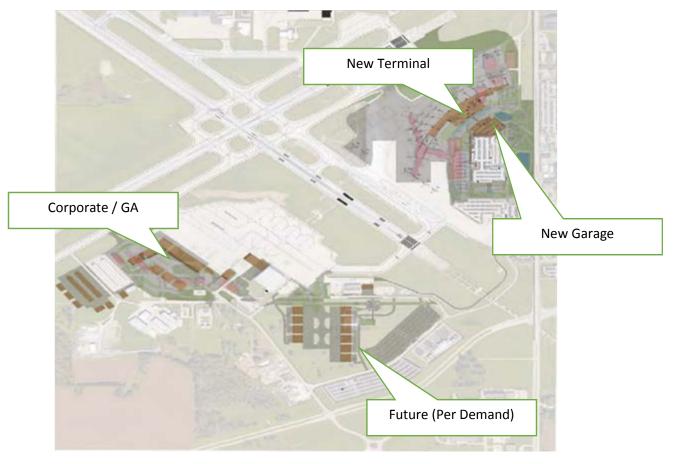
#### Figure 1. East Terminal Plan and Roadway Network

The Des Moines International Airport Terminal Programming Study developed from the planned addition of a new airport terminal east of the existing terminal, adding 14 gates to Des Moines International Airport (DSM), with long term expansion to 18 gates. A traffic impact study was completed to assess the future traffic demand generated by additional airport gates, increased and relocated parking, relocation of the main airport entrance, and general population growth.

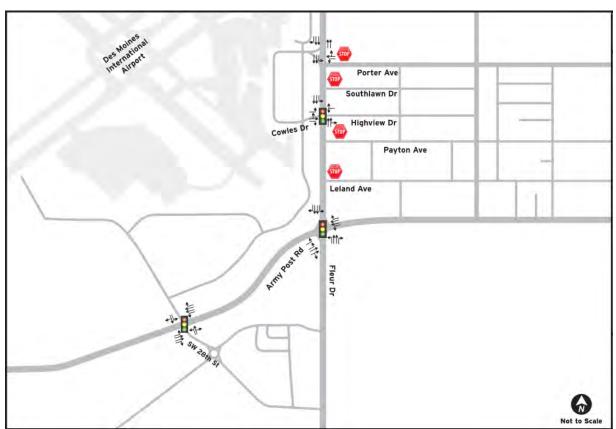
Figure 2: Study Area Intersections

The study includes a Synchro and SimTraffic analysis of intersections on Fleur Drive and Army Post Road (**Figure 2**), a roadway and intersection safety and operations analysis, and an inventory of existing and proposed bicycle, pedestrian, and transit accommodations. Recommendations concerning roadway geometry and traffic control are provided.

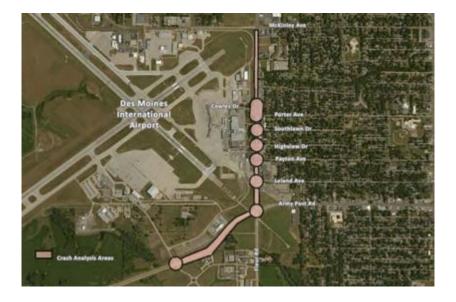
#### Figure 4. Crash Analysis Areas

DSM plans to construct a new terminal and 4-level parking structure to the northeast of the existing terminal. This will accommodate additional passengers and provide additional parking facilities at the airport. This safety analysis memorandum seeks to determine if any crash safety issues are present within the project area. Existing safety conditions were evaluated within the project study area to determine crash patterns and characteristics. Crash data was obtained from the lowa DOT for the years 2011 to 2015. The study area includes Army Post Road from SW 28<sup>th</sup> Street to Fleur Drive and Fleur Drive from Army Post Road to McKinley Avenue. **Figure 4** show the analysis areas.

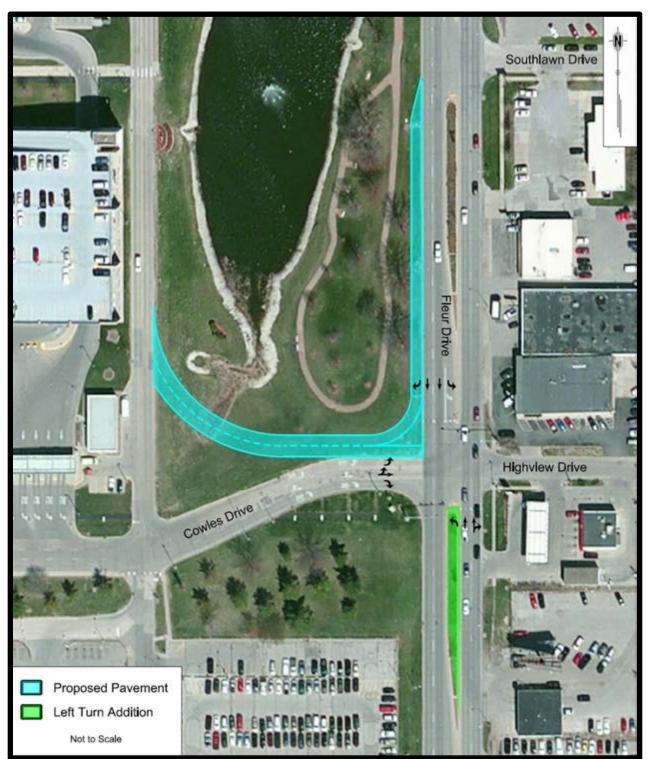
Figure 14. Proposed Geometric Configuration

The proposed configuration of Fleur and Cowles/Highview is shown in **Figure 14** below. The full set of recommended preliminary design plans is shown in **Appendix C**. The following improvements are recommended for the future (2040) conditions, pending discussions between the airport and city as well as outcomes from the City of Des Moines transportation master plan:

- For the new Highview / Cowles / Fleur intersection, only a single northbound left and single southbound right are needed inbound into the Airport while maintaining the current configuration of the rest of the intersection. If pedestrian access is desired along the north side or west side of the intersection, the southbound right should be signal controlled instead of free-flow as was originally proposed. The existing outbound configuration (dedicated eastbound left, shared eastbound left / through, and dedicated eastbound right) is expected to remain operating at LOS D or better through 2040. No changes are recommended to other movements.

- Improving Fleur to six lanes from Army Post Road to at least McKinley Avenue would improve the traffic operations of the corridor, but would likely necessitate the closure of side roads to maintain safety. This improvement is not being recommended in the near term, but closing the side road access is the only solution capable of producing acceptable level of service at all the unsignalized intersections. However, due to the public impact, the City of Des Moines may decide this is not a tenable solution.

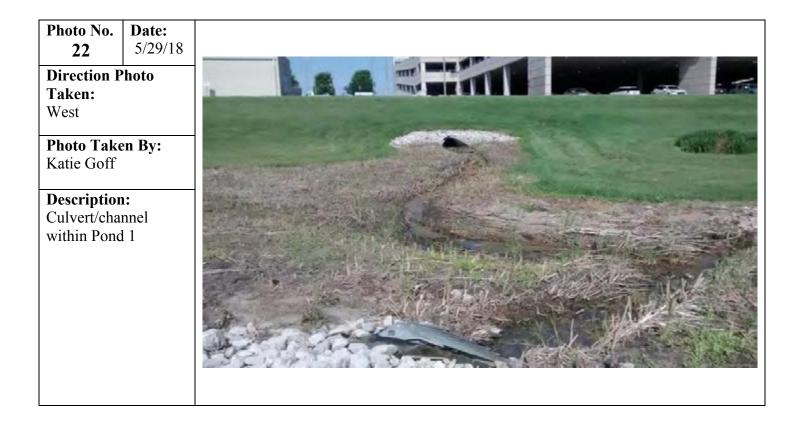
Photo No. 21	<b>Date:</b> 5/29/18	
Direction Photo Taken: South Photo Taken By: Katie Goff Description:		
Pond 1		A REAL PROPERTY AND ADDRESS OF A DESCRIPTION OF A DESCRIP

Wat	Waters of the United States Description		
WUS ID	Pond 1 (Stormwater Detention Basin)		
Approximate Area	1.4 acres		
Photograph ID	21, 22, 23		
Name of Water Body	Unnamed stormwater detention basin		
Location	East of the terminal building adjacent to Fleur Drive		
WUS Type	Artificial, constructed prior to the 1950s		
Bank Description	Un-vegetated due to mowing/maintenance practices		
Wetland Fringe	A wetland fringe would likely grow along the pond/stormwater detention basin fringe if left unmaintained. Regular maintenance is needed to prevent creation of a hazardous wildlife attractant within the airport grounds.		
Aquatic Organisms	No observed		
NWI Map Designation	Palustrine Emergent Persistent Seasonally Flooded Excavated (PEMCx), Palustrine Unconsolidated Bottom Intermittently Exposed Diked/Impounded Excavated (PUBGhx)		
	Prepared by: <u>ESN</u>

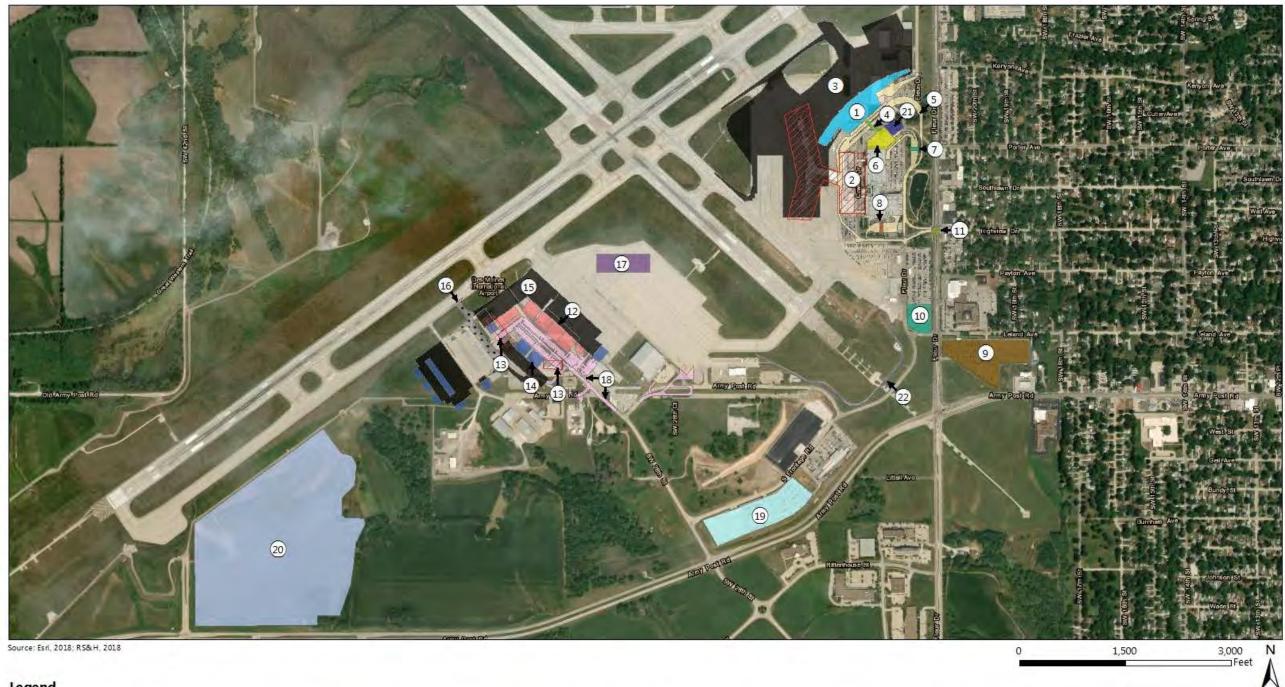
Figure 2 Proposed Action

- Replacement Passenger Terminal Building (1)
- Building Demolition (2, 13)
- Apron Expansion (3, 15)
- Elevated Pedestrian Bridge (4)
- Roadway Loop/Curbside Realignment (5)
- Parking Structure (6) Entry Plaza to Parking (7) Exit Plaza from Parking (8) Employee Parking (9) Cell Phone Lot (10)
- Entry Intersection at Fleur Drive (11) Signature and DSM Flying Services Relocation (12) General Aviation Hangars (14) Taxiway Entry (16) Cargo Deicing Pad (17)
- South Roadway and Parking Improvements (18) Construction Borrow Area (20) Dry Detention Basin (21) Fuel Road Improvements (22)

Rental Car Customer Service Building and Ready-Return Area (19)
